# **Jon Bronemann Home Inspections, LLC**

## **Property Inspection Report**

1234 Hometown Drive, Anytown, IA  
Inspection prepared for: Mr. and Mrs. America  
Date of Inspection: 9/15/2015 Time: 8:00 AM  
Age of Home: 1904 Size: 5468  
Weather: Clear, 70s by end of the inspection

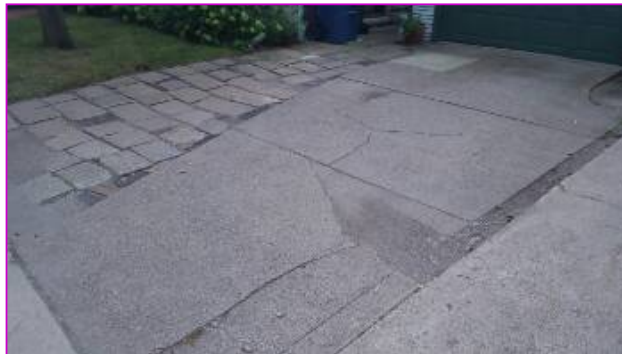
- Significant cracks in the driveway should be filled with an appropriate material to avoid continued damage to the driveway surface from freezing moisture.
- Trip hazards in the driveway appeared to be the result of the expansion or contraction (heaving or settling) of underlying soil. This condition should be corrected by a qualified contractor.

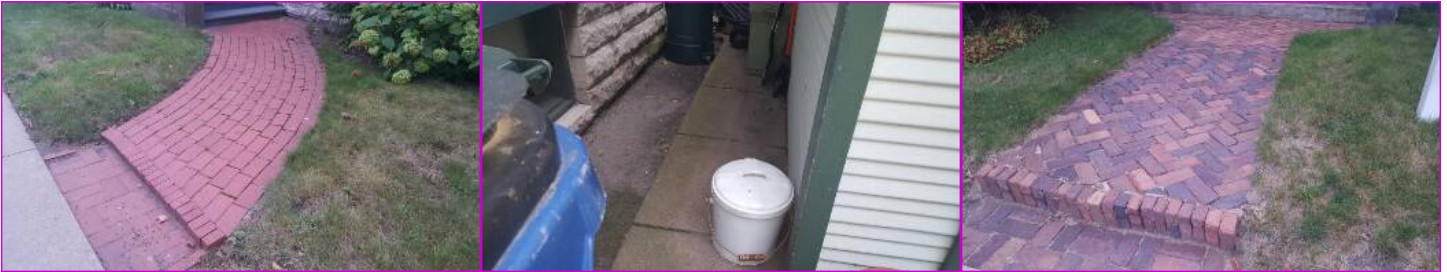
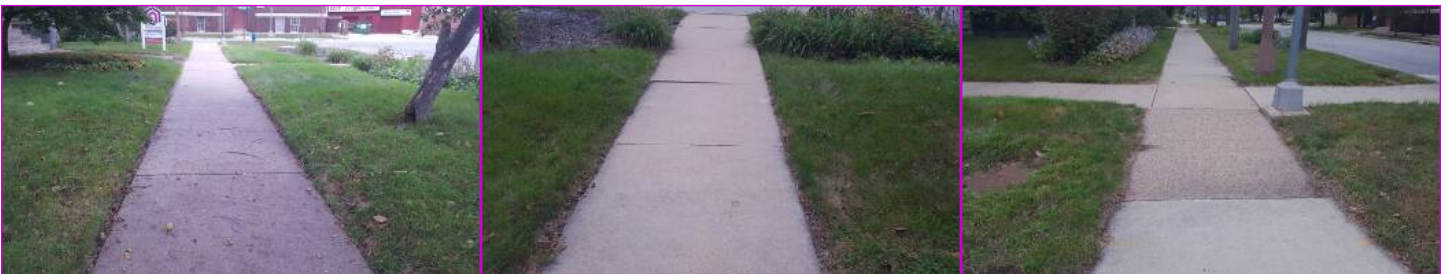
- Home walkways were constructed of brick pavers and concrete.
- At the time of the inspection, the Inspector observed few deficiencies in the condition of the walkways at the time of the inspection. Notable exceptions will be listed in this report.
- Common cracks (1/4 inch or less) were visible in the sidewalk at the time of the inspection. Cracks exceeding 1/4 inch should be patched with an appropriate sealant to avoid continued damage to the walkway surface from freezing moisture.
- Moderate settling of soil beneath the walkways had created trip hazards that should be corrected by a qualified contractor.

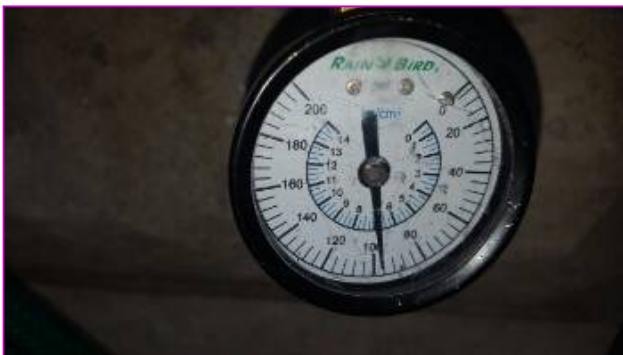
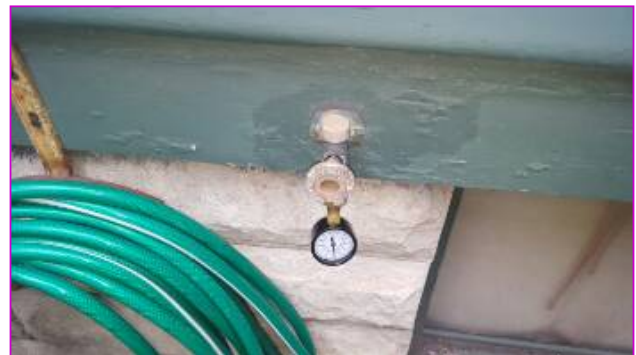
- Home water pressure exceeded 90 pounds per square inch (psi) at the time of the inspection. This is considered excessively high. Excessively high water pressure can damage plumbing fixtures. Acceptable water pressure is between 40 and 90 psi. The Inspector recommends installation of a pressure regulator by a qualified plumbing contractor.

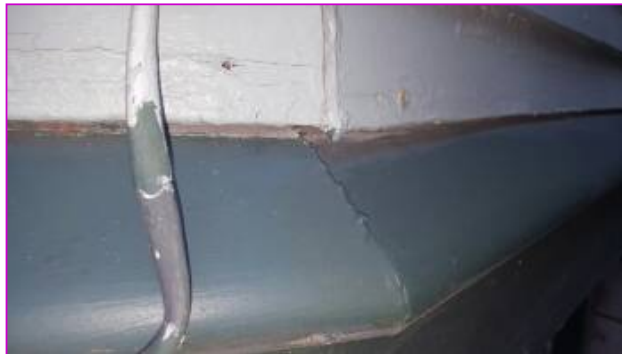
- Wood siding covering the exterior walls of the home had areas of peeling paint visible at the time of the inspection. Paint should be maintained in good condition to help prevent damage to wood siding from sun and moisture. The Inspector recommends that before the expiration of your Inspection Objection Deadline you consult with a qualified contractor to gain an idea of options and costs for repair. Painting and caulking will be a continuous maintenance issue with wood siding.

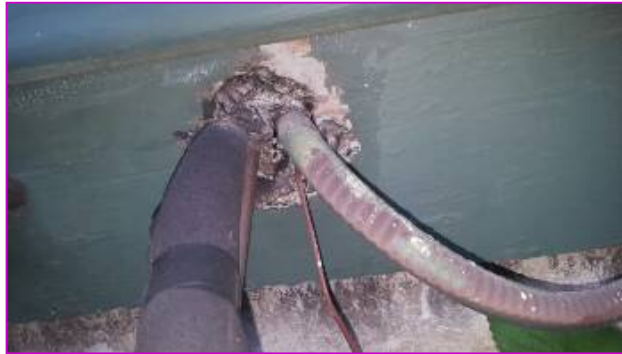
- Exterior wall penetrations had gaps that should be sealed with an appropriate sealant to prevent moisture and insect entry. All work should be performed by a qualified contractor.

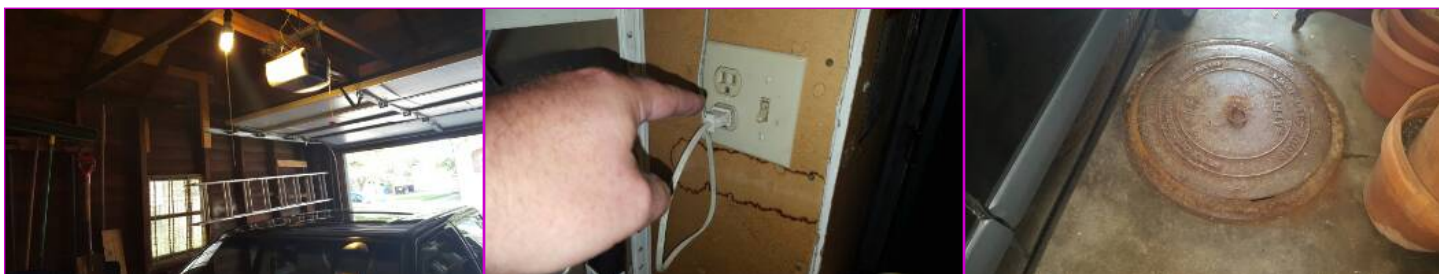
*GFCI devices needed in garage.*

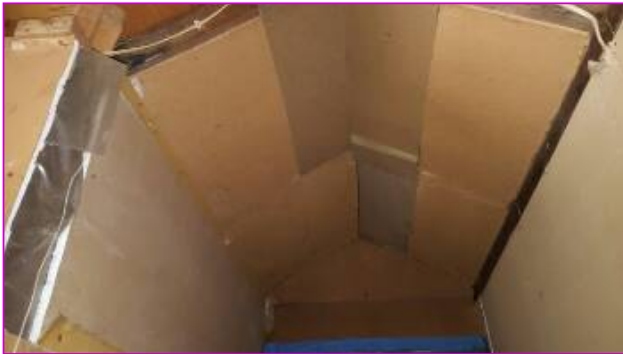
- Garage ceilings were drywalled, but not fire-taped. Modern building practices require that fire-taped drywall be installed on any ceiling adjoining living space for safety reasons. The Inspector recommends drywall be fire-taped to comply with modern safety requirements related to safety hazards.

*Gypsum board needed for fire separation.*

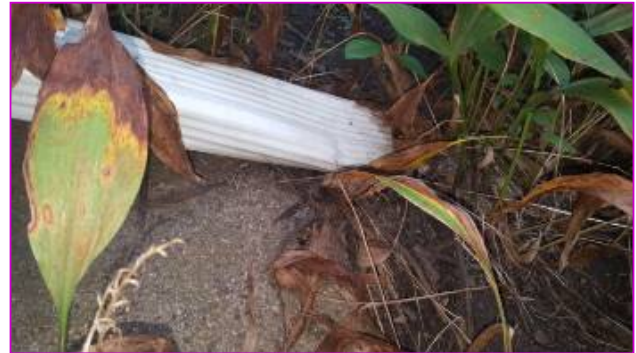
- The Inspector observed few deficiencies in the condition of the downspouts. Notable exceptions will be listed in this report.
- One or more downspouts designed to discharge roof drainage needed to be re-connected in order to properly control roof run-off. Disconnected downspouts can cause excessively high moisture levels in soil next to the foundation that can effect the ability of the soil to support the weight of the structure above and/or can cause damage related to soil/foundation movement. The Inspector recommends re-connection of any disconnected downspouts to help protect the home structure. All work should be performed by a qualified contractor.

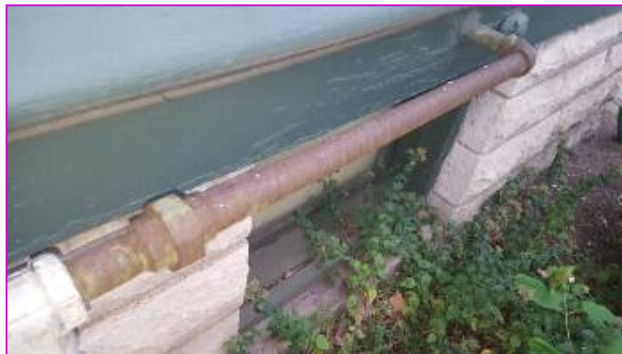
- The home gas distribution pipes were black steel.
- Gas pipes in the home exhibited moderate general corrosion. If this condition continues it may eventually cause gas pipes to leak, introducing toxic gas into the living space. The source / cause of moisture causing this corrosion should be located and the condition corrected. Recommend painting the piping. All work should be performed by a qualified contractor.

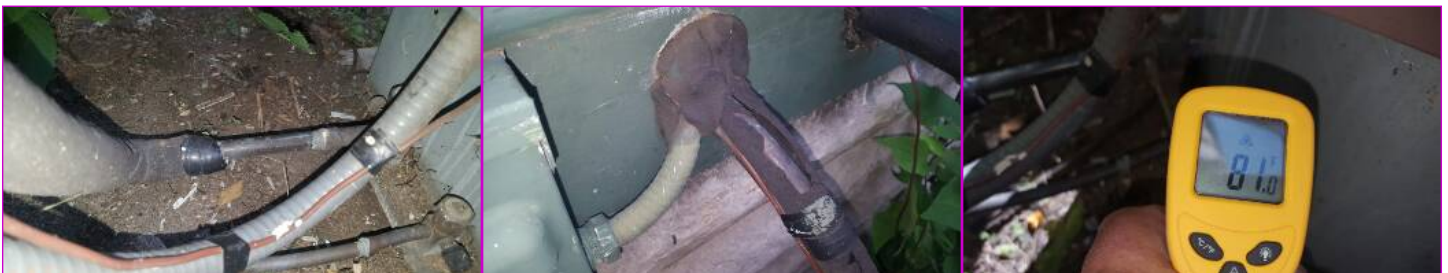
Unit #1 AC refrigerant lines.

• Insulation on the air-conditioning suction (large, insulated) line was damaged or missing at areas and should be replaced by a qualified HVAC contractor. The temperature difference between the liquid and suction line was not that noticeable to the touch while the system was running. This may be an explanation for why the coil unit inside was not producing cooler air than it was. Have the HVAC technician check the coolant level of each unit.

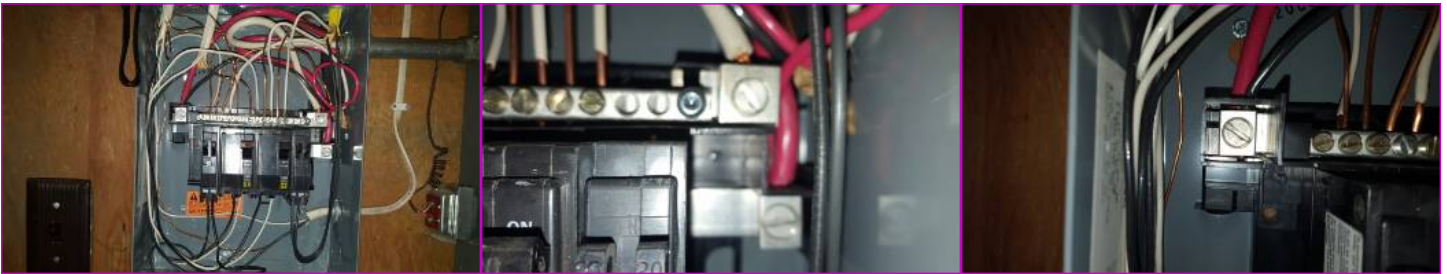
*Grounds and neutrals should not be on the same termination bar in a sub panel.*

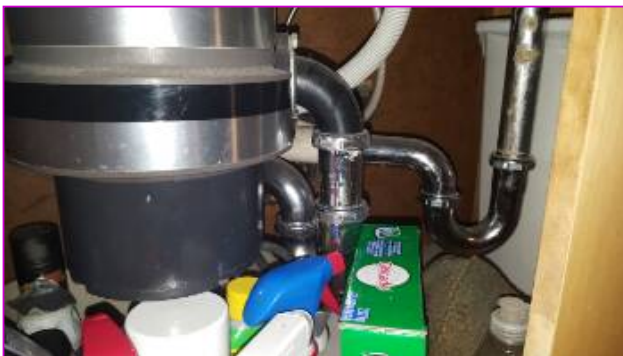
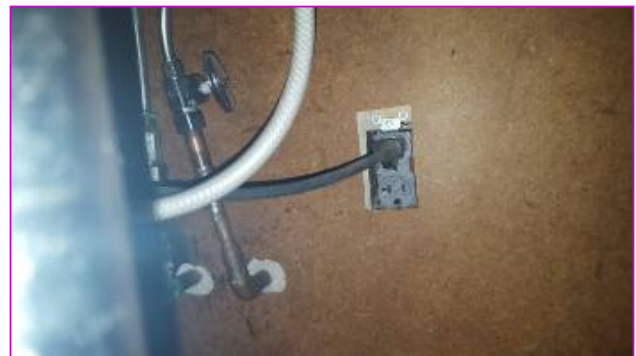
*Missing cover plate.*

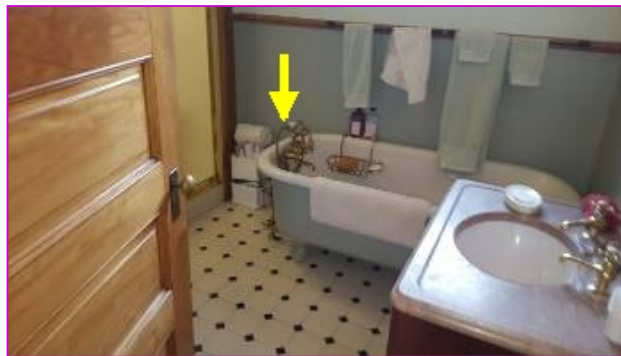
- A faucet handle at the tub in this bathroom was inoperable. The selection lever on the faucet would not allow the shower wand to be shut off and water change direction to the spout only. The Inspector recommends service by a qualified contractor.

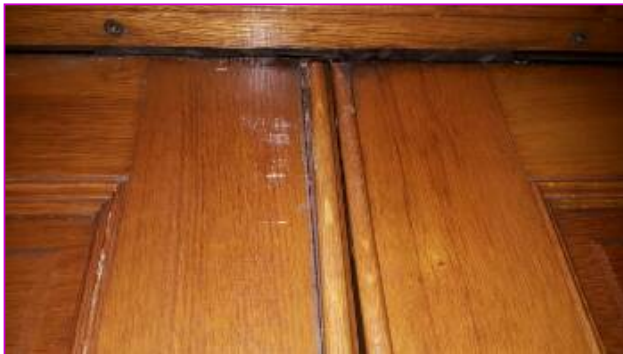
- One of the pocket doors in this room needs to be adjusted. It was out of plumb and would not close all the way.

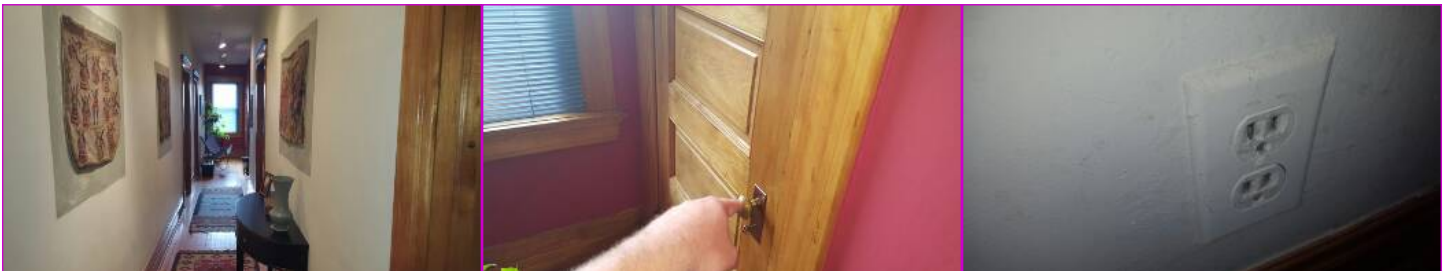
*Door does not latch properly.*

*Outlets are painted over. Typical of the many in the home.*

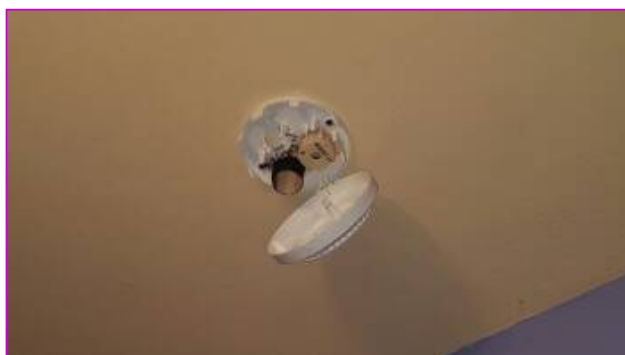
- A smoke detector in this room needed repair at the time of the inspection. The Inspector recommends repair by a qualified contractor to ensure that the safest possible conditions exist.

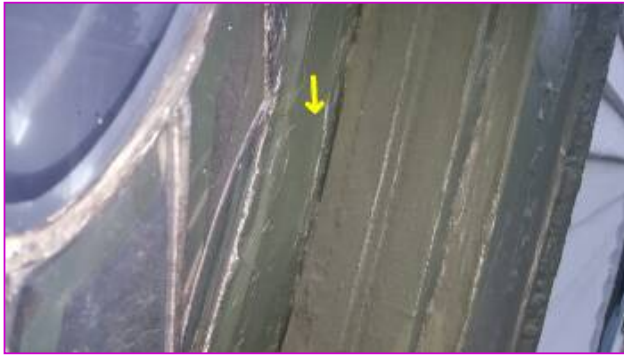
Page 11 Item: 2	Window Exterior Condition	<ul style="list-style-type: none"> <li>Sealant around windows was old, discolored, cracked, and needed maintenance to avoid potential moisture intrusion. The Inspector recommends maintenance be performed by a qualified contractor. The photo shows some areas needed at one of the ornamental windows as an example of typical caulking and painting necessary at windows and doors.</li> </ul>
-----------------	---------------------------	---

Peeling paint.

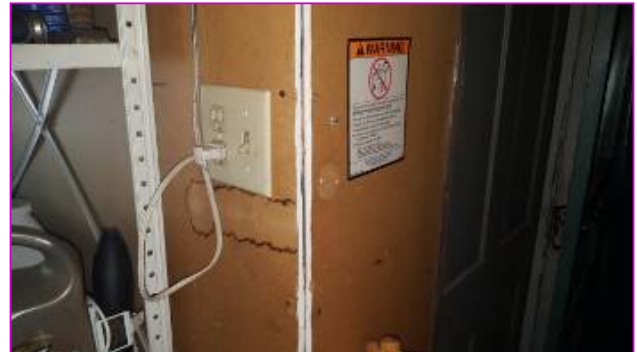
*Gypsum board needed for fire separation.*

*Joints should be finished for fire separation.*

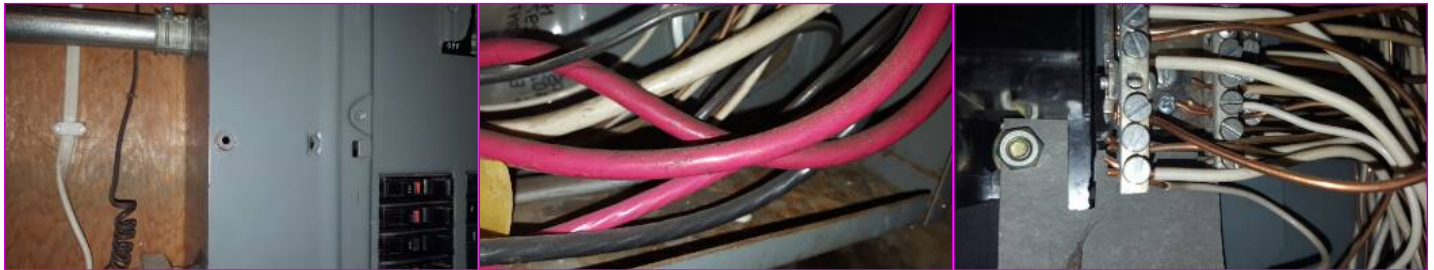
Page 47 Item: 3	Cabinet Condition	<ul style="list-style-type: none"> <li>The interior of the service panel exhibited general corrosion. The Inspector recommends that an evaluation and any necessary repairs be made by a qualified electrical contractor. See lower corners of the panel interior.</li> </ul>
-----------------	-------------------	---

Missing panel screws should be replaced.

Corrosion found in the panel box.

Grounds and neutrals should not be landed under the same screw in a main panel.

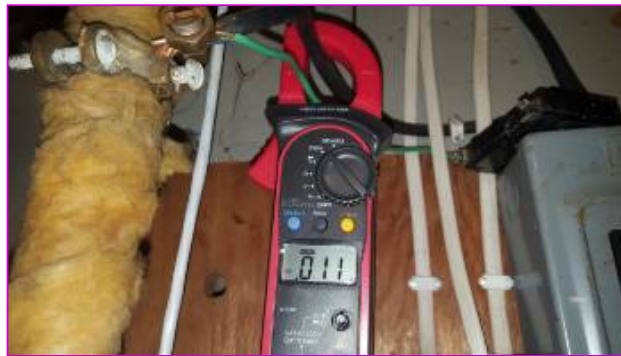
There was a small amount of current on the ground wire. Review recommended.

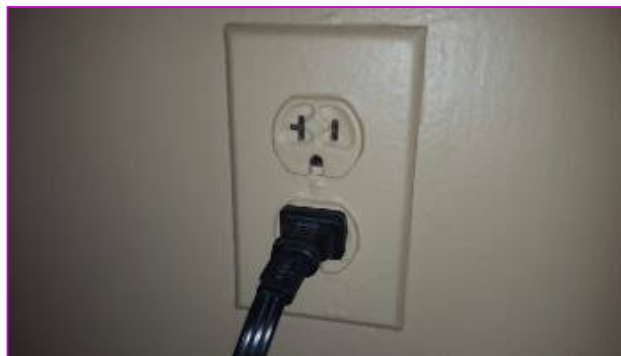
*Outlets that are painted should be replaced.*
