# **Jon Bronemann Home Inspections, LLC**

## **Property Inspection Report**

1234 Hometown Drive, Anytown, IA  
Inspection prepared for: Mr. and Mrs. America  
Date of Inspection: 9/15/2015 Time: 8:00 AM  
Age of Home: 1904 Size: 5468  
Weather: Clear, 70s by end of the inspection

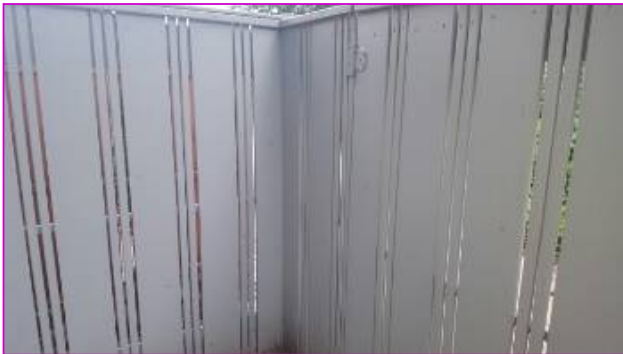
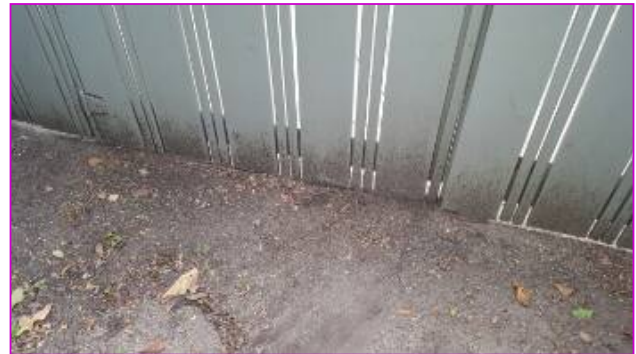
### 3. Fence Condition

- The inspector observed no deficiencies in the condition of the fences at the time of the inspection. Continued maintenance will need to be done to keep the fencing in good repair and appearance.

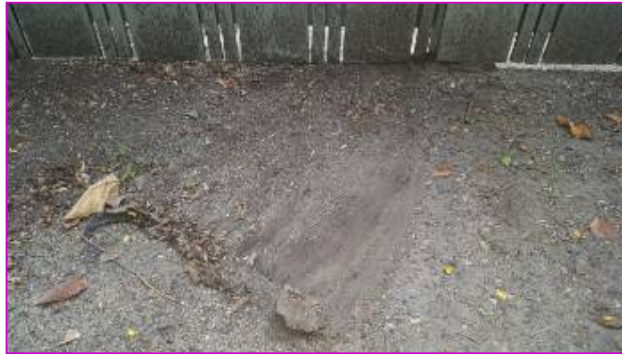
### 4. Gates

- The gates were made of wood.
- Gates were sticking at the time of the inspection. The gate rubbed on the ground as shown in the picture.

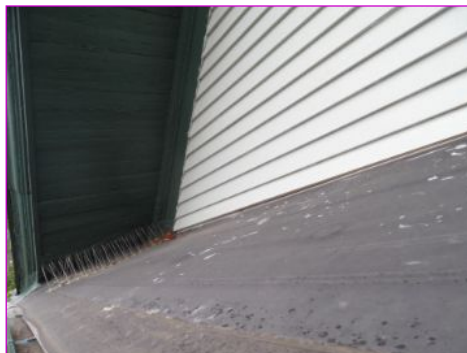
- At the time of the inspection, Home soffits exhibited moderate general deterioration commensurate with their age.

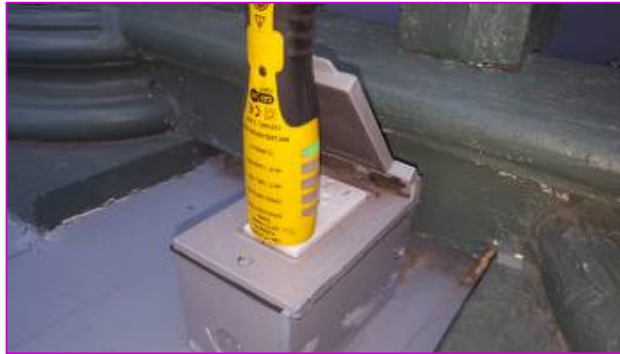
- The outdoor **GFCI** outlet at the front porch did not respond to testing when the button was pushed. Recommend that a licensed electrician replace the device.

*Test button failed to engage.*

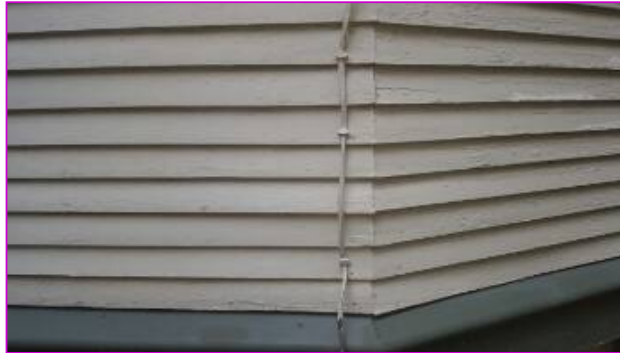
### 2. Exterior Electrical wiring

- Exterior wiring was exposed to weather and was of a type not designed for exterior use. This wiring will fail prematurely and is a potential fire hazard. The Inspector recommends that all such wiring be replaced by a qualified electrical contractor with wiring designed for exterior use. See light over window on left side of house.

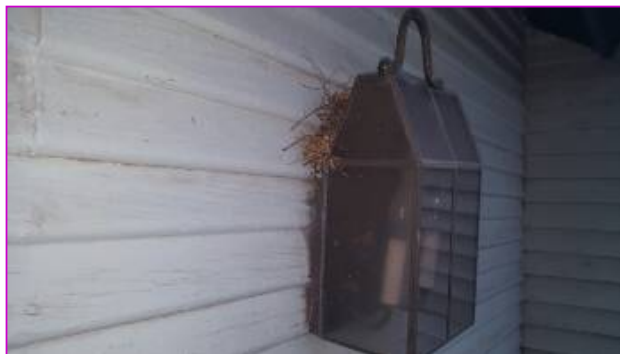
### 3. Exterior Lighting

- Remove birds nest at light fixture at patio area.

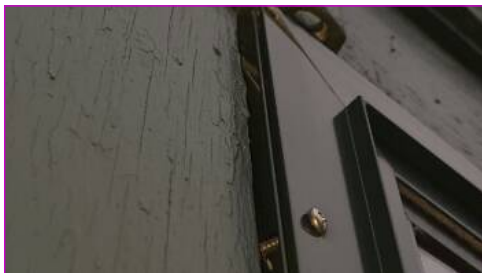
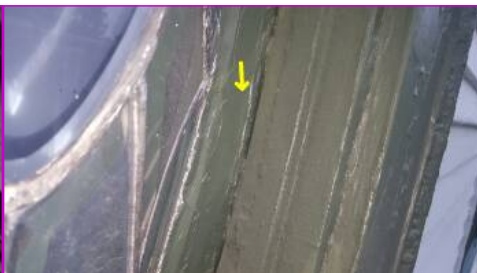
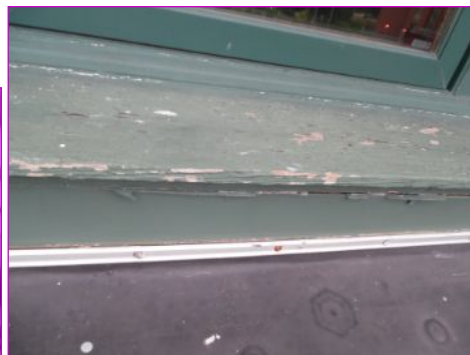
• Sealant around widows was old, discolored, cracked, and needed maintenance to avoid potential moisture intrusion. The Inspector recommends maintenance be performed by a qualified contractor. The photo shows some areas needed at one of the ornamental windows as an example of typical caulking and painting necessary at windows and doors.

*Peeling paint.*

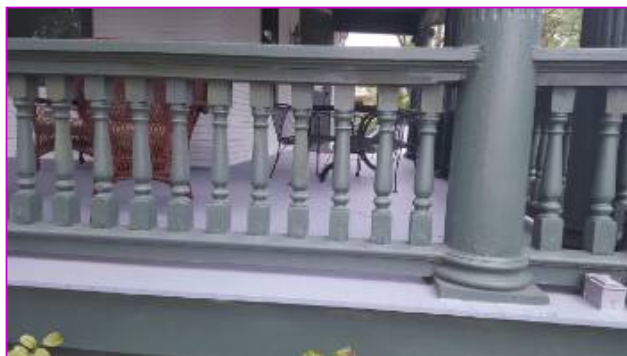
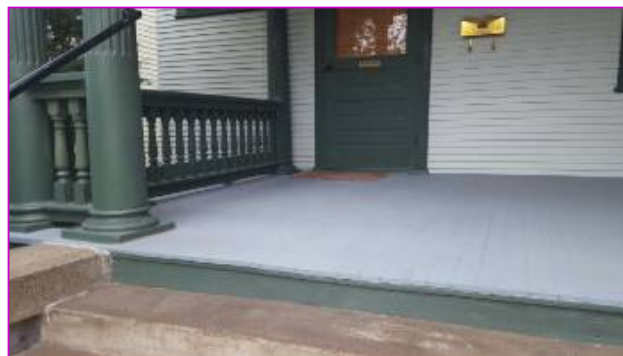
## 1. General Condition

- At the time of the inspection, the Inspector observed no deficiencies in the condition of the porch. The inspector was unable to determine if water would run off the porch during a rain. Some ponding may occur due to any uneven areas.

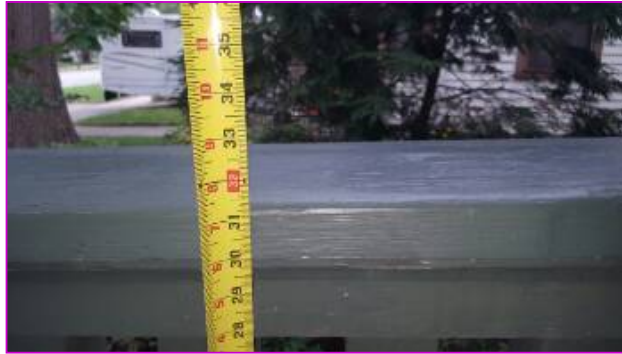
The porch failed to meet safety standard number(s) 3 and 4.

All corrections should be made by a qualified contractor.

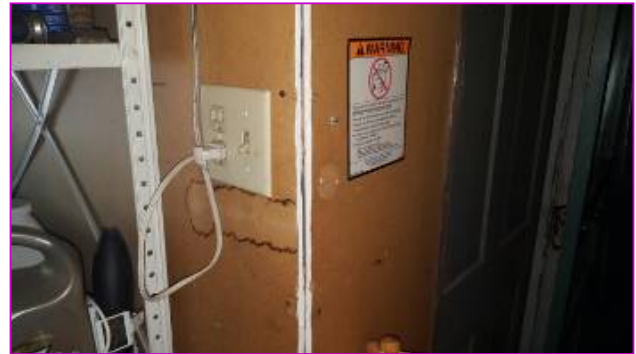
*Joints should be finished for fire separation.*

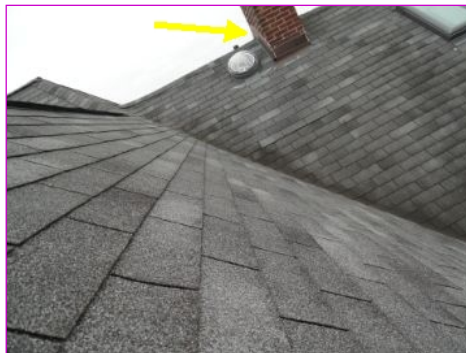
- Flashing installed at areas where the chimney penetrated the roof structure was not protected by counter-flashing. This condition may allow moisture to intrude behind the flashing and enter the roof structure, with the potential to cause decay of the roof sheathing or framing, microbial growth, or damage to other home materials. The inspector recommends installation of counter-flashing by a qualified contractor.

- Chimney flashing where the chimney penetrated the roof was protected by sealant alone where it attached to the exterior wall-covering material. Sealant will eventually dry, shrink and crack, allowing moisture intrusion with the potential to cause decay of the roof sheathing or framing, microbial growth, or damage to other home materials. This sealant should be diligently maintained in the future to avoid damage from moisture intrusion. All work should be performed by a qualified contractor.

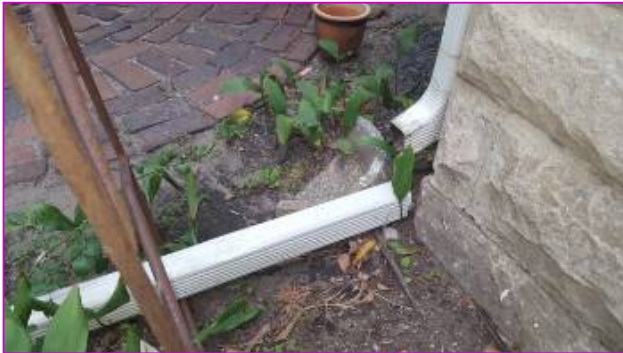
### 4. Downspouts

- The Inspector observed few deficiencies in the condition of the downspouts. Notable exceptions will be listed in this report.
- One or more downspouts designed to discharge roof drainage needed to be re-connected in order to properly control roof run-off. Disconnected downspouts can cause excessively high moisture levels in soil next to the foundation that can effect the ability of the soil to support the weight of the structure above and/or can cause damage related to soil/foundation movement. The Inspector recommends re-connection of any disconnected downspouts to help protect the home structure. All work should be performed by a qualified contractor.

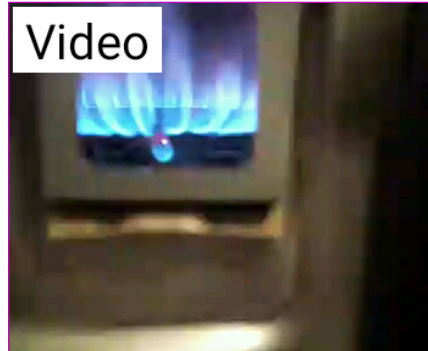
- The water heater burn chamber was clean and in good condition at the time of the inspection.

*Good.*

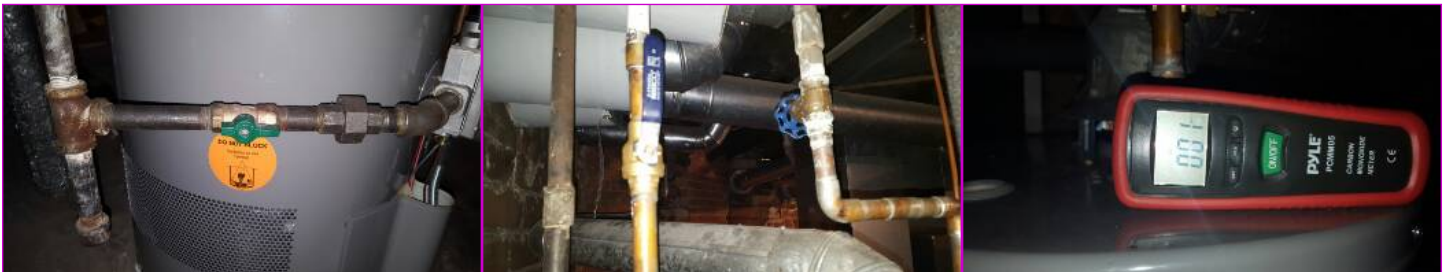
*CO level at water heater. Good.*

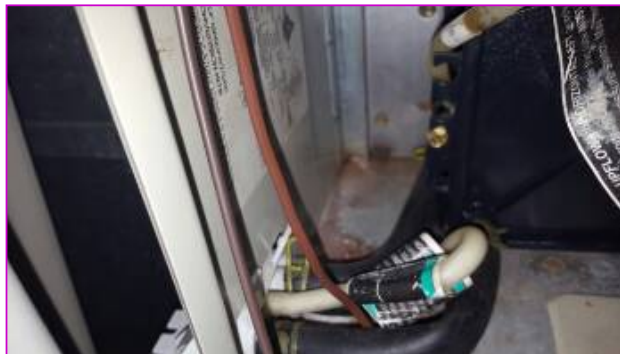
- The Inspector specifically disclaims furnace heat exchangers because proper evaluation requires invasive, technically exhaustive measures that exceed the scope of the General Home Inspection. Because of the age of the furnace, The Inspector recommends that you have it certified by a qualified HVAC contractor.
- The Inspector recommends that furnace cleaning, service and certification be performed by a qualified HVAC contractor.

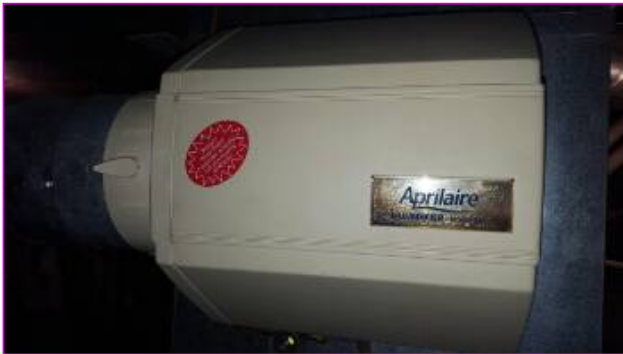
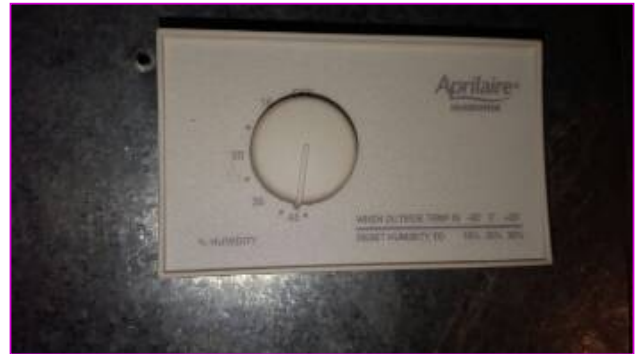
- The home had a humidifier installed at the furnace. The humidifier was controlled by a humidistat installed nearby.

Many homeowners do not understand the maintenance requirements connected with these appliances and the Inspector recommends that you contact the humidifier manufacturer to ask about any maintenance requirements.

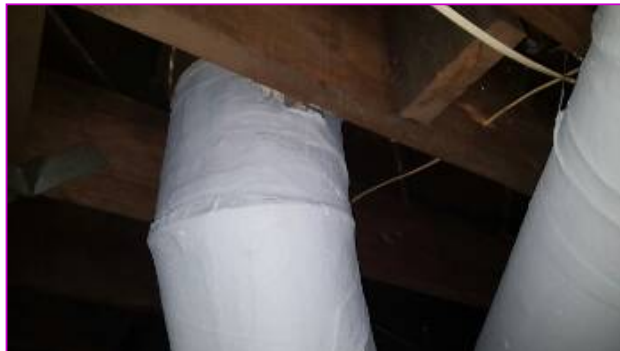
- Air supply ducts were not sealed. The Inspector recommends sealing supply and return air ducts with mastic or tape to improve the HVAC system efficiency. All work should be performed by a qualified heating, ventilation and air-conditioning (HVAC) contractor.

- HVAC ducts visible in the were not electrically bonded. To help ensure safe electrical and fire safety conditions, the Inspector recommends that HVAC ducts be properly bonded to the home electrical system.
- The ductwork was covered with an unknown material. This material may contain asbestos. You should ask the home owner to verify the type of material this is and also have it independently tested to see if it contains asbestos. If it does contain asbestos you should consider have it professionally removed. The inspector recommends that you do your verification prior to expiration of your Inspection Period.

*Possible asbestos duct covering*

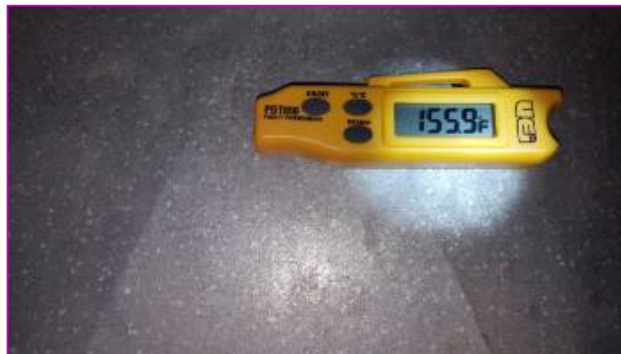
- This furnace responded adequately to the call for heat.

*Good.*

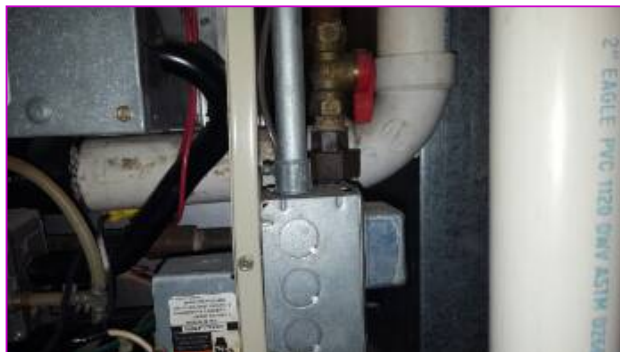
- The furnace electrical and gas shut-offs are shown in the photo.

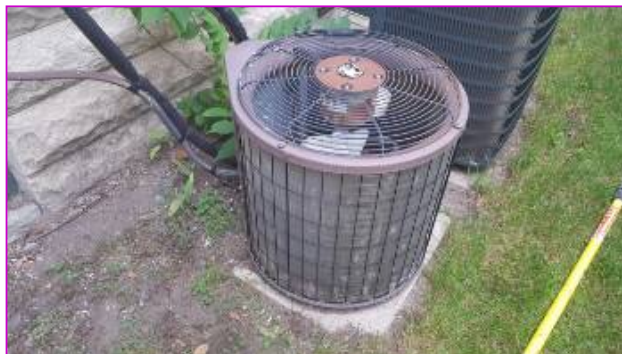
*Outside unit #1 for main level of home. Made in 1994. Needs servicing.*

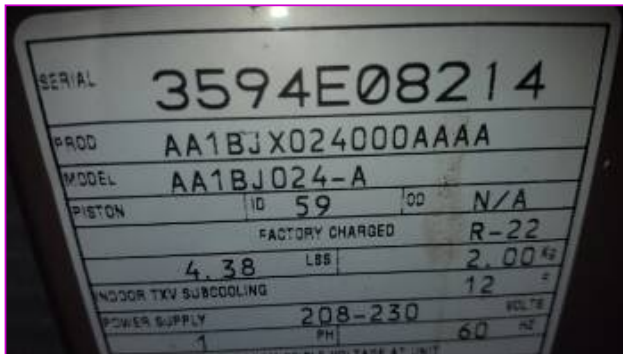
Unit #1 Outdoor compressor data plate.

- Information from the air-conditioner label/data plate of the outdoor compression is shown in the photo.
- The manufacturer was Resco. This is a brand of Carrier unit that is a builder grade model.
- The model number of the unit was AA1BJ024-A.
- The serial number of the unit was 3594E08214.
- The air-conditioner date of manufacture appeared to be 35th week of 1994.

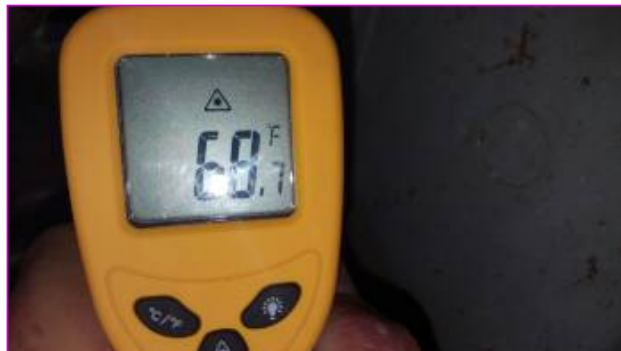
• Insulation on the air-conditioning suction (large, insulated) line was damaged or missing at areas and should be replaced by a qualified HVAC contractor. The temperature difference between the liquid and suction line was not that noticeable to the touch while the system was running. This may be an explanation for why the coil unit inside was not producing cooler air than it was. Have the HVAC technician check the coolant level of each unit.

Unit #1 AC refrigerant lines.

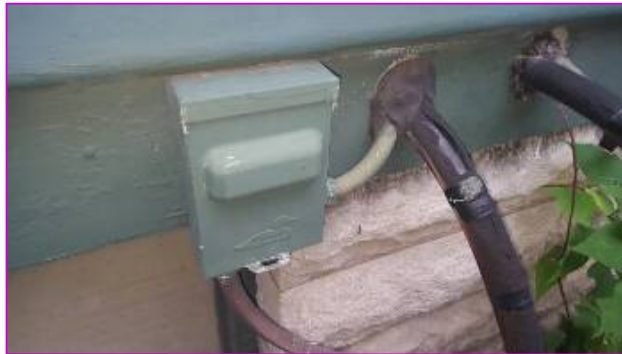
*Unit #1 AC unit disconnect.*

- Although it was not operated, the electrical disconnect for the condensing unit appeared to be properly located and installed at the time of the inspection. It was not operated.

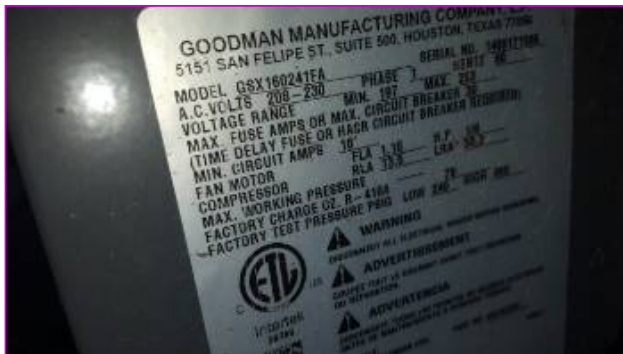
AC #2 outdoor compressor unit data plate.

- Information from the inside and outdoor air-conditioner equipment label/data plate is shown in the photo.

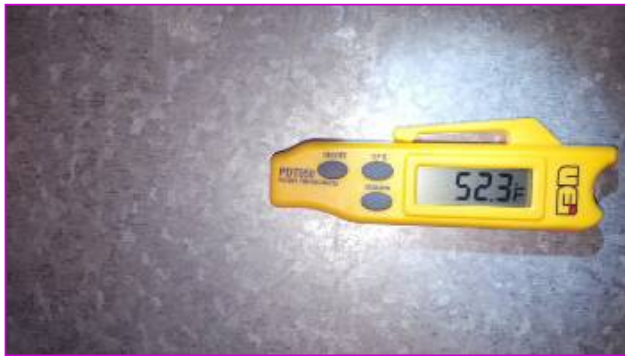
- The differences in air temperature measured at supply and return registers fell within the acceptable range of between 14 and 22 degrees F.

Supply air temp of 52 deg F.

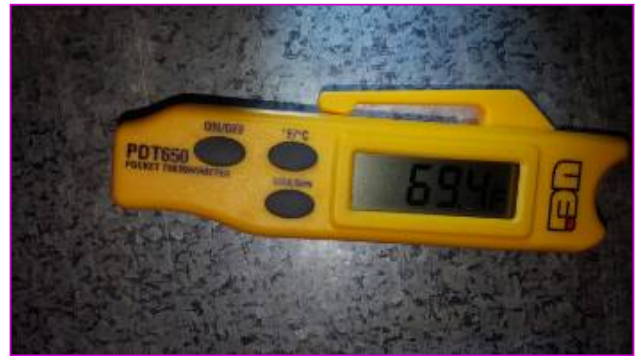
Return air temp of 69 deg F.

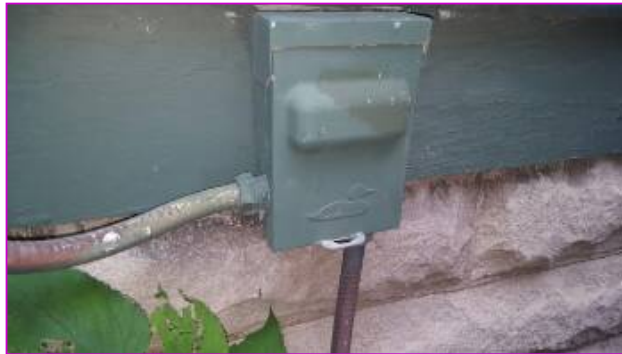
- Although it was not operated, the electrical disconnect for the condensing unit appeared to be properly located and installed and in serviceable condition at the time of the inspection.

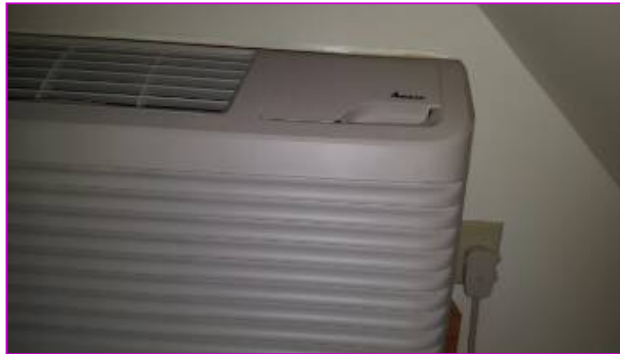
- The wall-mounted air-conditioning/heating unit appeared to be in serviceable condition at the time of the inspection and produced cool air upon demand. Inspection of wall-mounted air-conditioning units is limited to confirmation of proper operation.

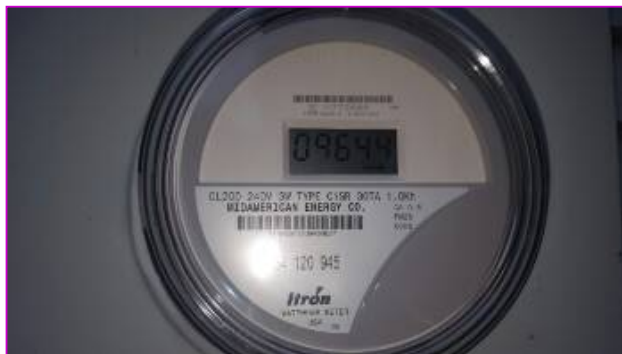
- The electric meter was located at the rear of the home.

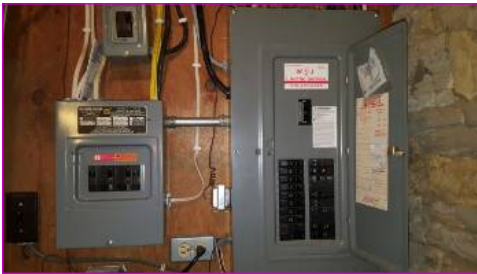
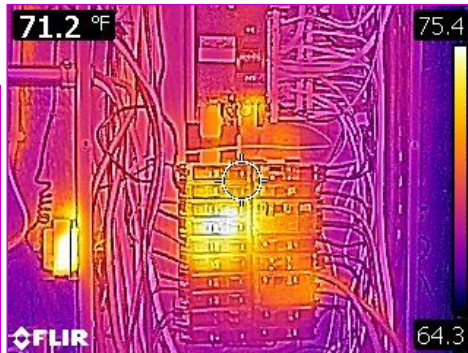
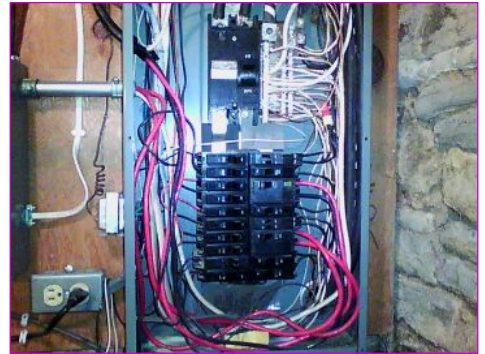
Showing breaker temps. Normal range reported.

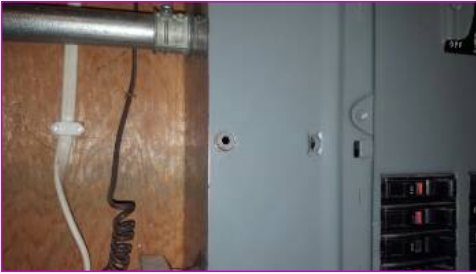
Missing panel screws should be replaced.

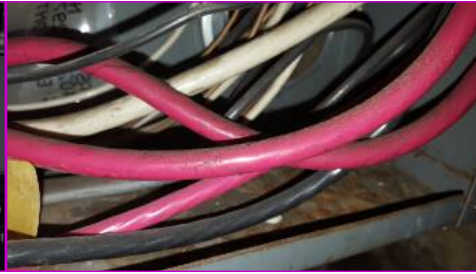
- The interior of the service panel exhibited general corrosion. The Inspector recommends that an evaluation and any necessary repairs be made by a qualified electrical contractor. See lower corners of the panel interior.

Corrosion found in the panel box.

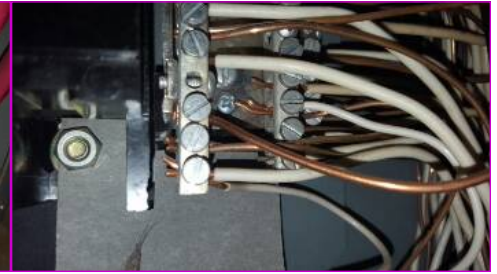
Grounds and neutrals should not be landed under the same screw in a main panel.

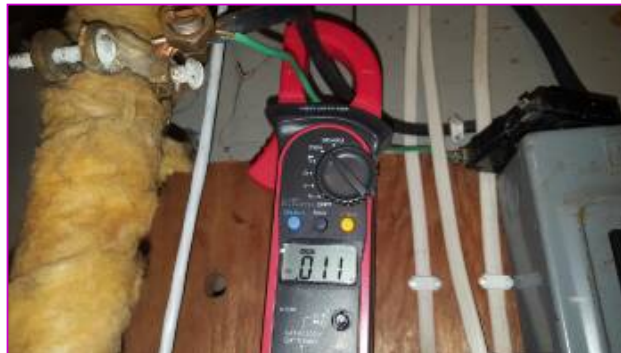
There was a small amount of current on the ground wire. Review recommended.

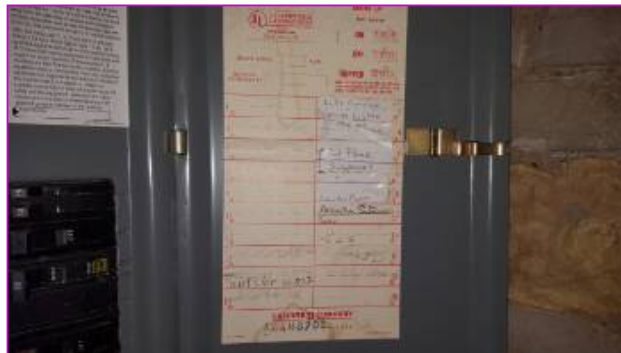
- The Circuit Directory label for the service panel is shown in the photo.

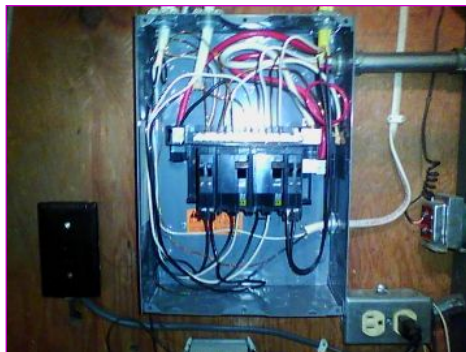
- A sub-panel is a metal cabinet containing overcurrent devices such as breakers or fuses that protect electrical circuits in the home. Power to branch circuit breakers in this sub-panel was controlled by a main disconnect located in the service panel. This subpanel was located in the basement next to the main service panel.

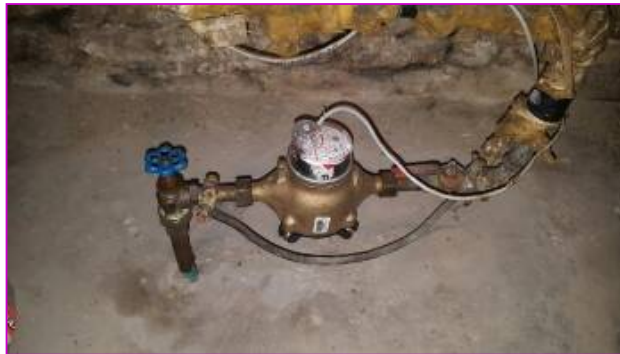
- The main water supply shut-off was located in the basement.

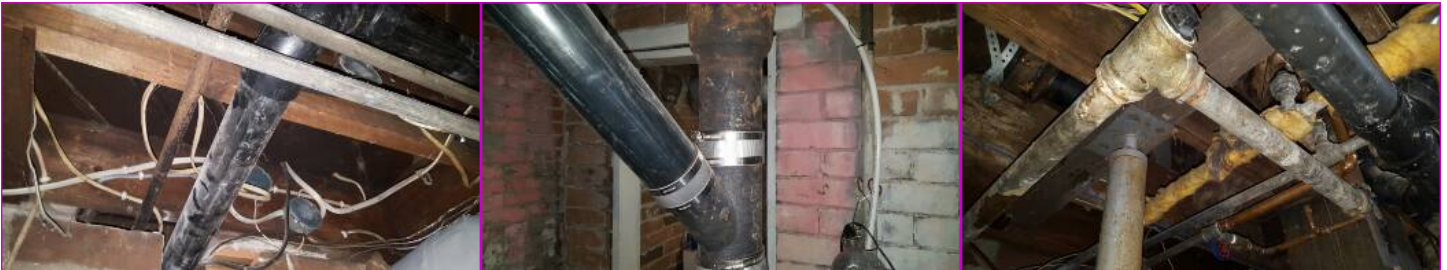
- The visible drain, waste and vent (DWV) pipes were a combination of PVC, ABS and cast iron metal and galvanized metal pipe. The metal pipes will corrode from the inside out and the diameter of the piping will reduce and cut down the functional flow over time. Continue to monitor the waste flow from plumbing fixtures for an future problems.

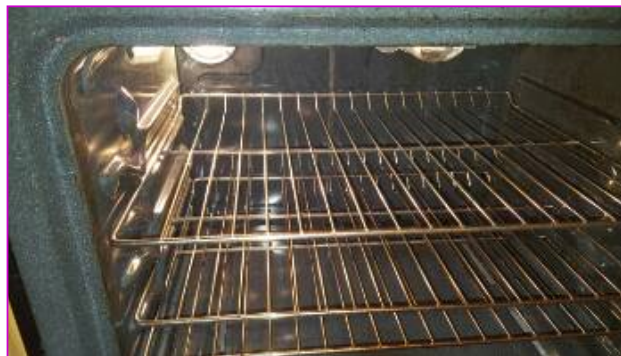
## 4. Range Condition

- The Inspector observed few deficiencies during inspection of the range. Notable exceptions will be listed in this report.
- The range was not fastened to the floor. A child standing on the open oven door could overturn the range. This condition is a life-safety issue. The Inspector recommends installation of an approved anti-tip device by a qualified contractor.

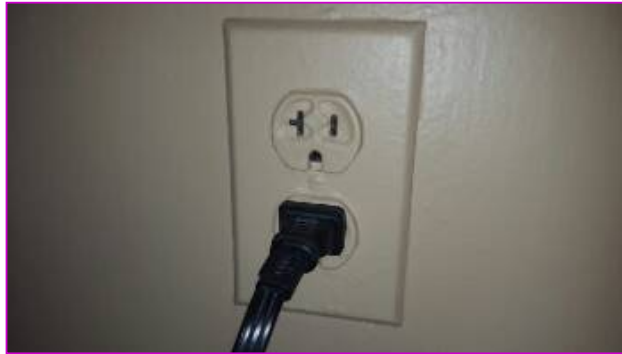
• Some of the outlets were painted over. This is not a recommended practice. It was also typical of many of the outlets in the entire home. You should consider replacing the outlets.

*Outlets that are painted should be replaced.*

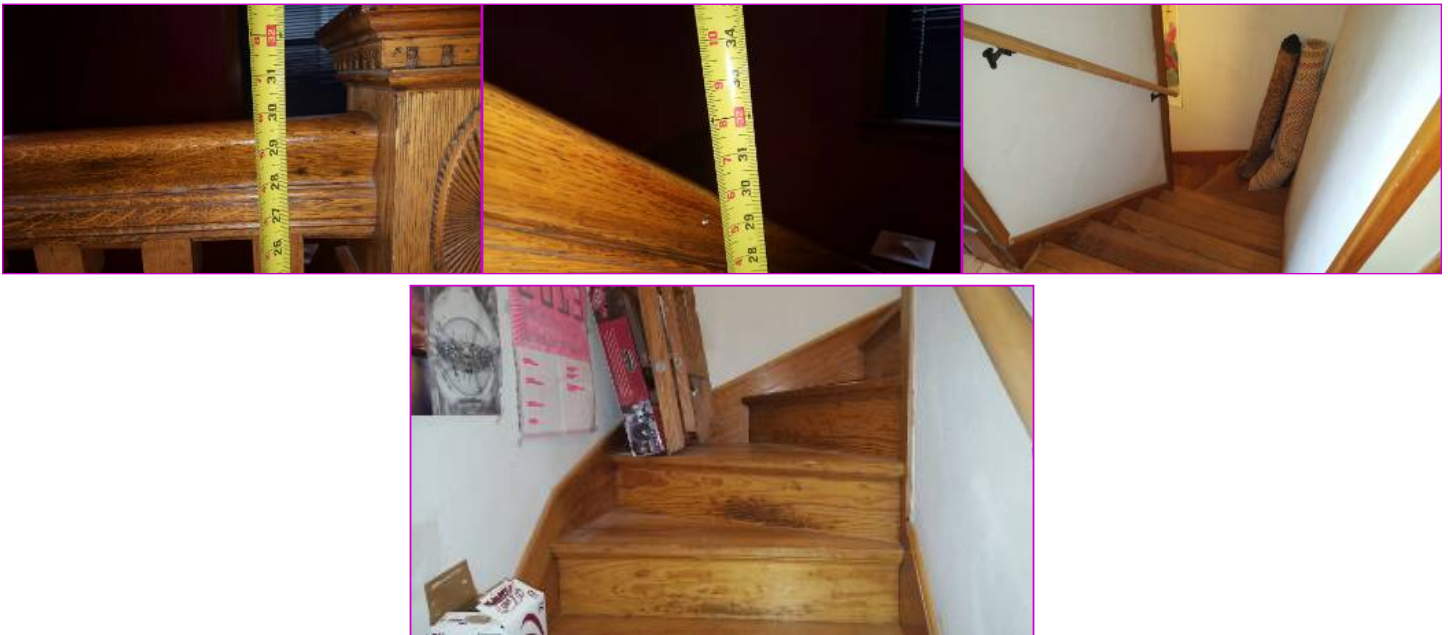
### 2. Guardrail Assembly

• The horizontal guardrails protecting this stairwell were less than 36 inches in height. Although this condition is now considered a potential fall hazard, it is not uncommon in older homes such as this one, built during a time period during which safety standards were different from generally-accepted current safety standards. Homes are not required to be updated to comply with newly enacted safety standards. Because this is a life-safety issue, the Inspector recommends having the guardrails altered or replaced with guardrails at least 36 inches in height to comply with modern safety standards.

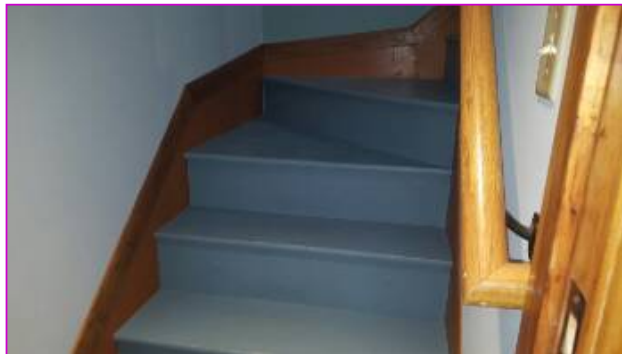
### 2. Guardrail Assembly

- The horizontal guardrails protecting this stairwell were less than 36 inches in height. This condition is a potential fall hazard. The Inspector recommends that this condition be updated to meet generally-accepted modern safety standards by a qualified contractor.

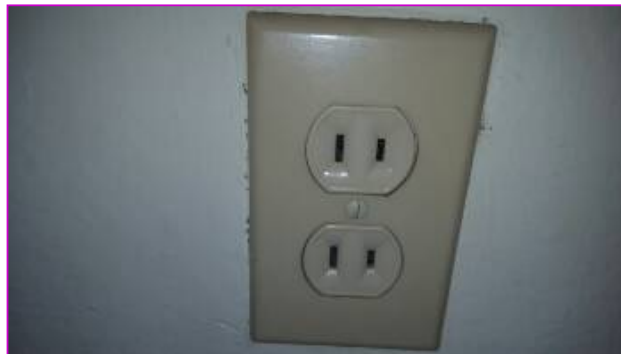
#### 2. Electrical Receptacles

- An electrical outlet in this bedroom had an open ground. Other outlets in the home were grounded. This outlet should be corrected by qualified electrical contractor.

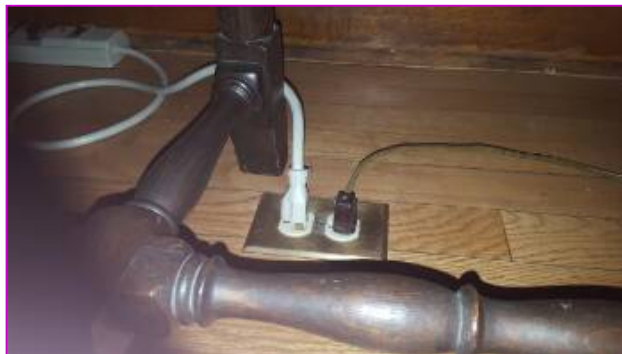
- The floor outlets in the home should be replaced to a type that protects the device when not in use. See a licensed electrician for this work.

*Floor outlets in the home should be replaced to protect device when not in use.*

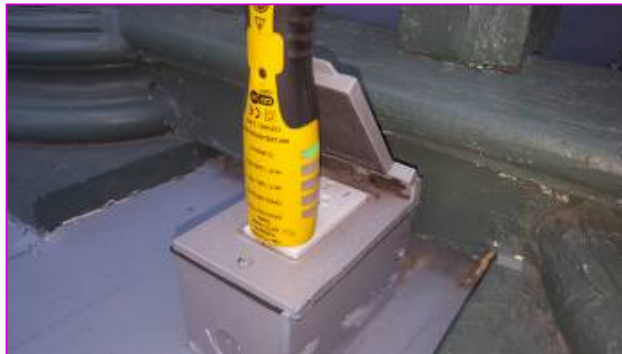
Page 8 Item: 1	Exterior Electrical Receptacles	<ul style="list-style-type: none"> <li>The outdoor <b>GFCI</b> outlet at the front porch did not respond to testing when the button was pushed. Recommend that a licensed electrician replace the device.</li> </ul>
----------------	---------------------------------	--

*Test button failed to engage.*

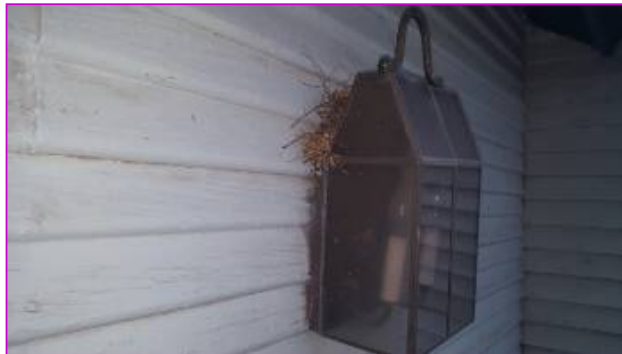
Page 9 Item: 2	Exterior Electrical wiring	<ul style="list-style-type: none"> <li>Exterior wiring was exposed to weather and was of a type not designed for exterior use. This wiring will fail prematurely and is a potential fire hazard. The Inspector recommends that all such wiring be replaced by a qualified electrical contractor with wiring designed for exterior use. See light over window on left side of house.</li> </ul>
----------------	----------------------------	--

Page 9 Item: 3	Exterior Lighting	<ul style="list-style-type: none"> <li>Remove birds nest at light fixture at patio area.</li> </ul>
----------------	-------------------	---

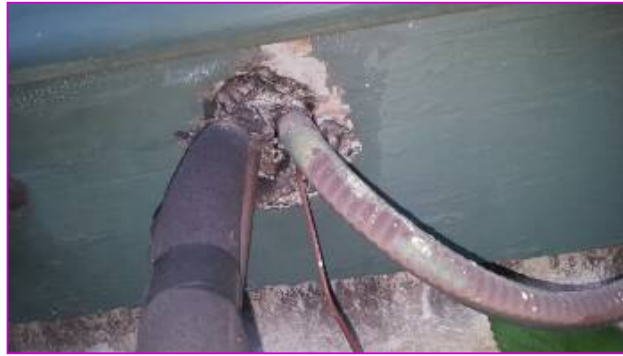
Page 10 Item: 3	Wall Penetrations	<ul style="list-style-type: none"> <li>Exterior wall penetrations had gaps that should be sealed with an appropriate sealant to prevent moisture and insect entry. All work should be performed by a qualified contractor.</li> </ul>
-----------------	-------------------	---

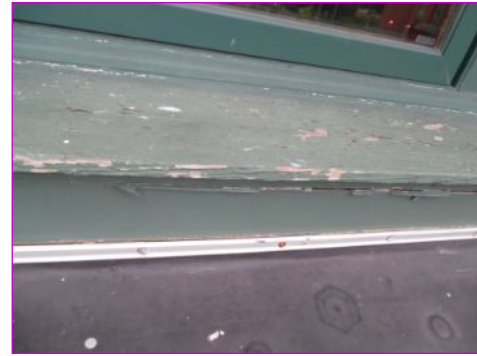
Page 11 Item: 2	Window Exterior Condition	<ul style="list-style-type: none"> <li>Sealant around windows was old, discolored, cracked, and needed maintenance to avoid potential moisture intrusion. The Inspector recommends maintenance be performed by a qualified contractor. The photo shows some areas needed at one of the ornamental windows as an example of typical caulking and painting necessary at windows and doors.</li> </ul>
-----------------	---------------------------	---

Peeling paint.

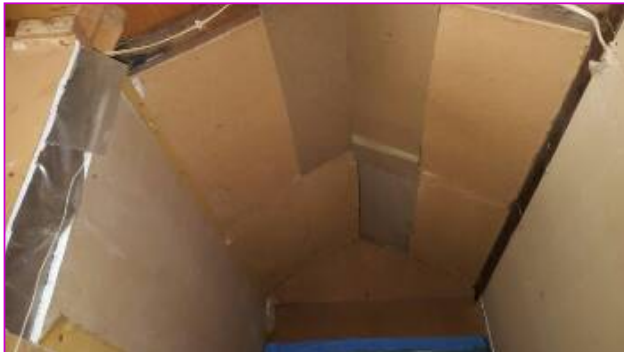
<p>Page 15 Item: 3</p>	<p>Fire Separation</p>	<ul style="list-style-type: none"> <li>• The walls separating the garage from the home living space did not meet firewall requirements. Although firewalls may not have been required at the time the home was originally constructed, as general knowledge of safe building practices has improved with the passage of time, building standards have changed to reflect current understanding. Consider updating the existing condition to meet current firewall requirements.</li> <li>• Garage walls adjoining living space were not fire-taped as is required by generally-accepted current safety standards. The Inspector recommends that the wall be fire-taped by a qualified contractor.</li> <li>• The ceiling separating the garage from the home living space did not meet firewall safety requirements. The Inspector recommends correction by a qualified contractor.</li> <li>• No drywall was installed on garage ceilings adjoining living space. Generally-accepted current safety standards require that fire-taped, 5/8-inch, type -x drywall be installed on any garage ceiling adjoining living space for safety reasons. The Inspector recommends that drywall be installed by a qualified contractor to comply with modern safety requirements related to safety hazards.</li> <li>• Garage ceilings were drywalled, but not fire-taped. Modern building practices require that fire-taped drywall be installed on any ceiling adjoining living space for safety reasons. The Inspector recommends drywall be fire-taped to comply with modern safety requirements related to safety hazards.</li> </ul>

*Gypsum board needed for fire separation.*

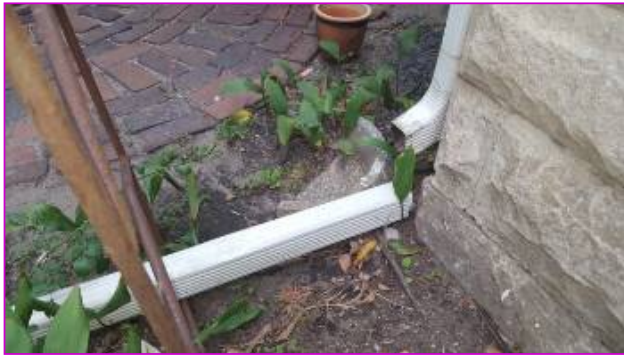
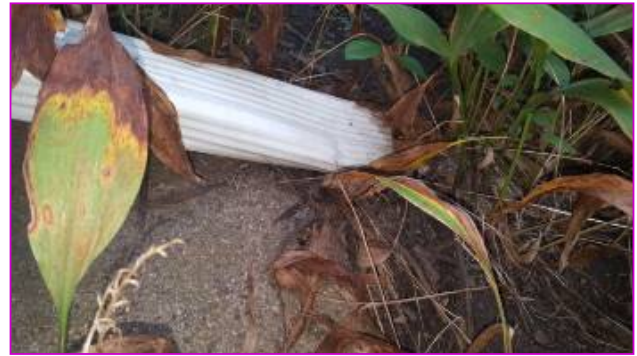
Page 24 Item: 4	Downspouts	<ul style="list-style-type: none"> <li>One or more downspouts designed to discharge roof drainage needed to be re-connected in order to properly control roof run-off. Disconnected downspouts can cause excessively high moisture levels in soil next to the foundation that can effect the ability of the soil to support the weight of the structure above and/or can cause damage related to soil/foundation movement. The Inspector recommends re-connection of any disconnected downspouts to help protect the home structure. All work should be performed by a qualified contractor.</li> </ul>
-----------------	------------	---

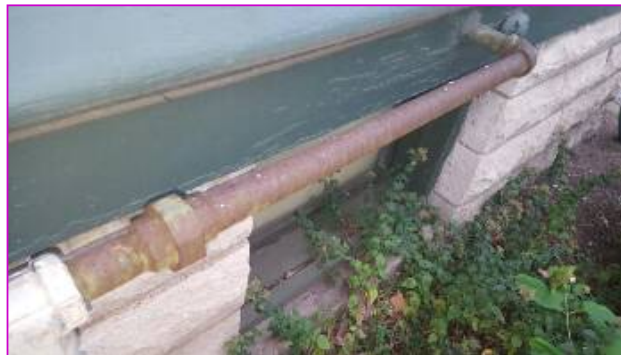
Page 25 Item: 3	Gas Distribution Pipes	<ul style="list-style-type: none"> <li>Gas pipes in the home exhibited moderate general corrosion. If this condition continues it may eventually cause gas pipes to leak, introducing toxic gas into the living space. The source / cause of moisture causing this corrosion should be located and the condition corrected. Recommend painting the piping. All work should be performed by a qualified contractor.</li> </ul>
-----------------	------------------------	---

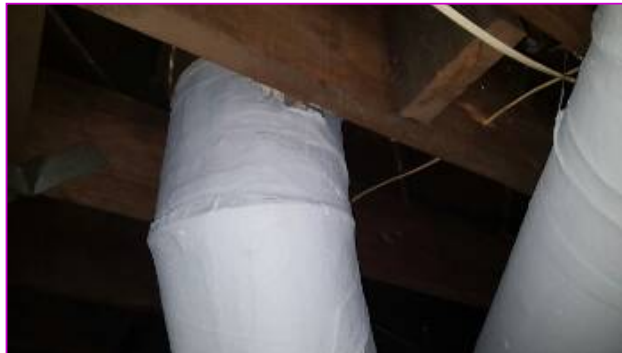
Page 31 Item: 15	Ducts	<ul style="list-style-type: none"> <li>• HVAC ducts visible in the were not electrically bonded. To help ensure safe electrical and fire safety conditions, the Inspector recommends that HVAC ducts be properly bonded to the home electrical system.</li> <li>• The ductwork was covered with an unknown material. This material may contain asbestos. You should ask the home owner to verify the type of material this is and also have it independently tested to see if it contains asbestos. If it does contain asbestos you should consider have it professionally removed. The inspector recommends that you do your verification prior to expiration of your Inspection Period.</li> </ul>

Possible asbestos duct covering

Page 42 Item: 4	HVAC Ducts	<ul style="list-style-type: none"> <li>Some of the ductwork was wrapped with a material that may contain asbestos. You should ask the seller to disclose the type of material shown and have it tested to verify.</li> </ul>
Page 42 Item: 6	Basement Electrical	<ul style="list-style-type: none"> <li>Extension cord used as house wiring visible in the basement at the time of the inspection is a potential fire hazard. The Inspector recommends removal of the extension cord and proper wiring be installed by a qualified electrical contractor. See light over furnace.</li> </ul>

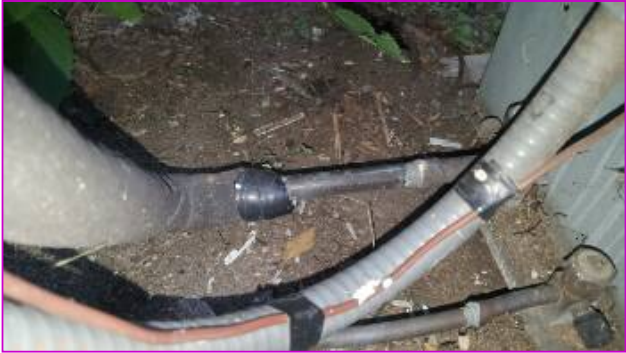
Page 36 Item: 6	AC Refrigerant Lines	<ul style="list-style-type: none"> <li>• Insulation on the air-conditioning suction (large, insulated) line was damaged or missing at areas and should be replaced by a qualified HVAC contractor. The temperature difference between the liquid and suction line was not that noticeable to the touch while the system was running. This may be an explanation for why the coil unit inside was not producing cooler air than it was. Have the HVAC technician check the coolant level of each unit.</li> </ul>

<p data-bbox="646 800 971 827"><i>Unit #1 AC refrigerant lines.</i></p>		
Page 37 Item: 10	Temperature Splits	<ul style="list-style-type: none"> <li>• The temperature of air measured just downstream from the evaporator coil was significantly higher than the target temperature of 55 degrees F. The Inspector recommends service by a qualified HVAC technician.</li> <li>• Air temperature measured at supply and return registers had a difference of less than the minimum of 14 degrees F. The Inspector recommends service by a qualified HVAC technician.</li> </ul>

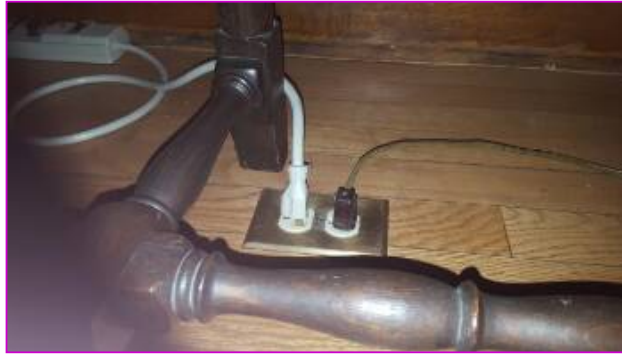
Page 70 Item: 1	General Condition	<ul style="list-style-type: none"> <li>At the time of the inspection, the Inspector observed few deficiencies in the condition of this room. Notable exceptions will be listed in this report.</li> </ul>
Page 70 Item: 2	Electrical Receptacles	<ul style="list-style-type: none"> <li>The floor outlets in the home should be replaced to a type that protects the device when not in use. See a licensed electrician for this work.</li> </ul>

*Floor outlets in the home should be replaced to protect device when not in use.*

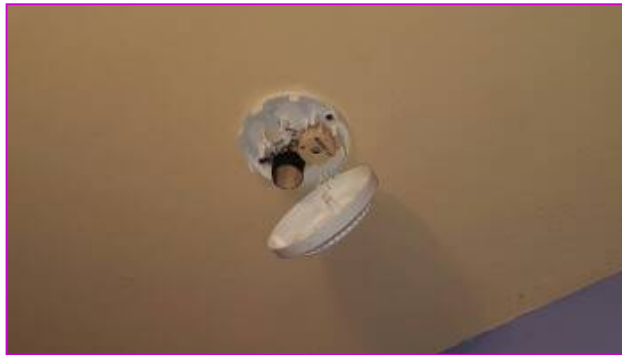
Page 71 Item: 4	Smoke/CO Detectors	<ul style="list-style-type: none"> <li>A smoke detector in this room needed repair at the time of the inspection. The Inspector recommends repair by a qualified contractor to ensure that the safest possible conditions exist.</li> </ul>
-----------------	--------------------	---
